20/20 Property Inspections, LLC

Property Inspection Report

123 ABC Circle, Billings, MT 59102
Inspection prepared for: John & Sally Smith
Real Estate Agent: -

Date of Inspection: 8/1/2019 Time: 1:00 PM
Age of Home: 2008 Size: 3126 sf
Weather: 92° F Sunny
Order ID: 215

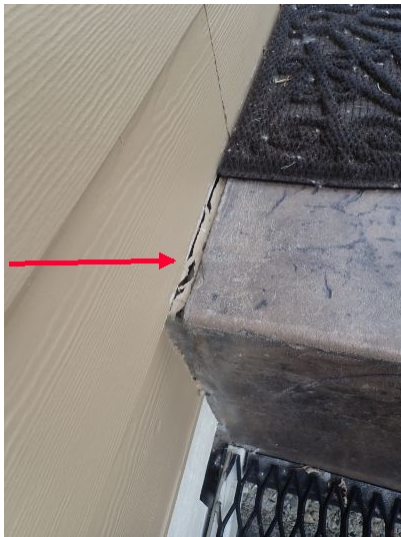
- The rear porch has settled and pulled away from the house structure. The gap that has opened up needs to be properly sealed/flushed to keep moisture and debris from getting between porch and house as this could result in damages to the house framing.
- The front porch has settled over 1" at the south. Cracking in the concrete noted between porch and stairs due to this movement. The inspector noted the lack of compacted soils under the SW corner of the porch. Soils need replaced and compacted to prevent any further movement. Consider consultation with a concrete repair contractor regarding slab jacking.

Separation between house wall and porch at the north side of the home.

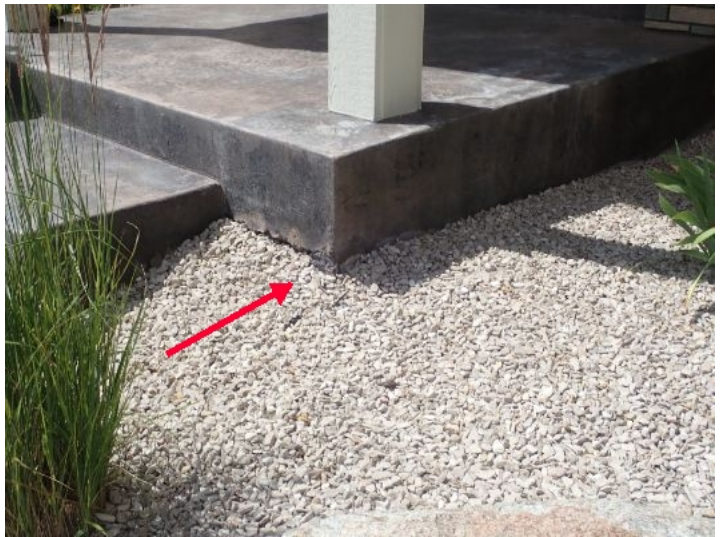
Note the lack of supporting soils under this corner of the concrete front porch.

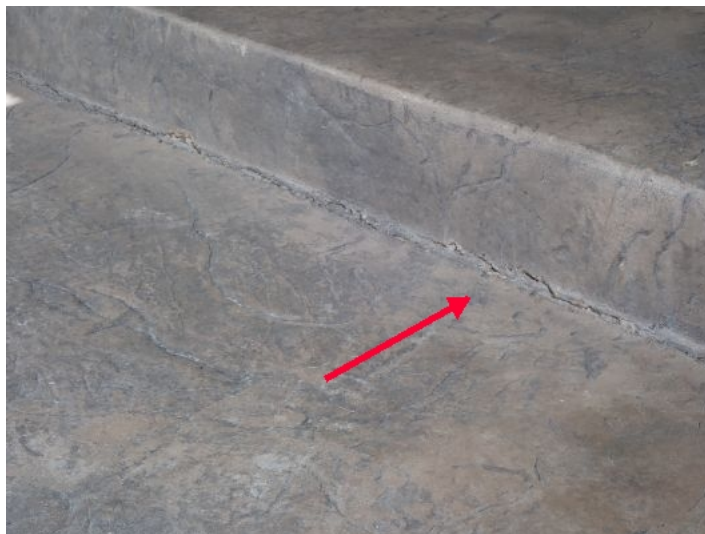
Cracking that has occurred due to settlement of the front porch.

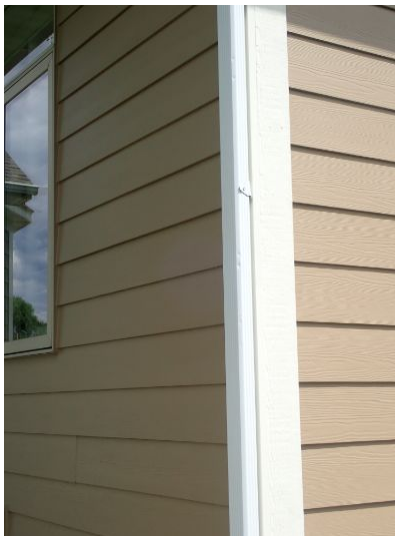
- The downspouts are hailstone damaged.

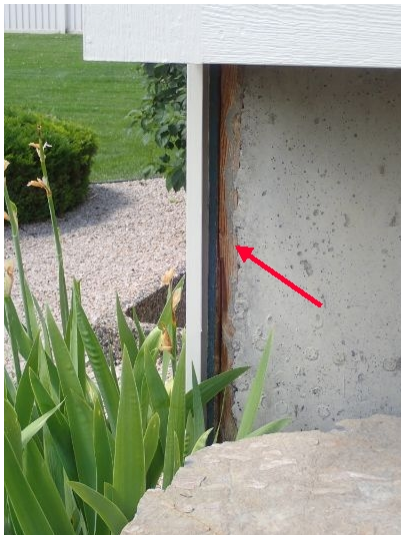
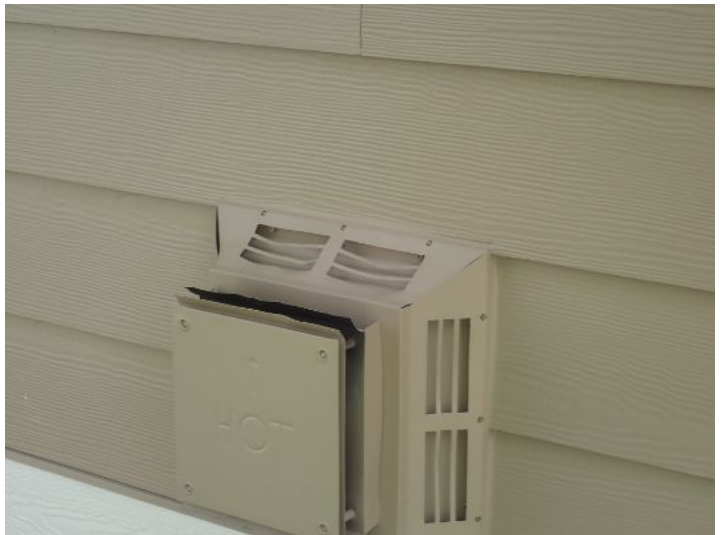
- Some damage to the gas insert exterior flue caps. Recommend a fireplace contractor review and replace if necessary.
- View of the house sheeting observed at the SW corner of the home. This is interior grade material and cannot be exposed to exterior elements. We recommend trimming this area out properly.

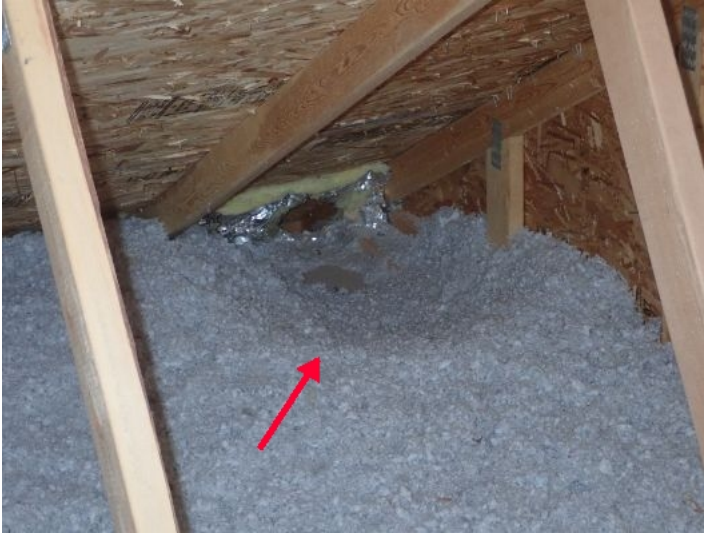
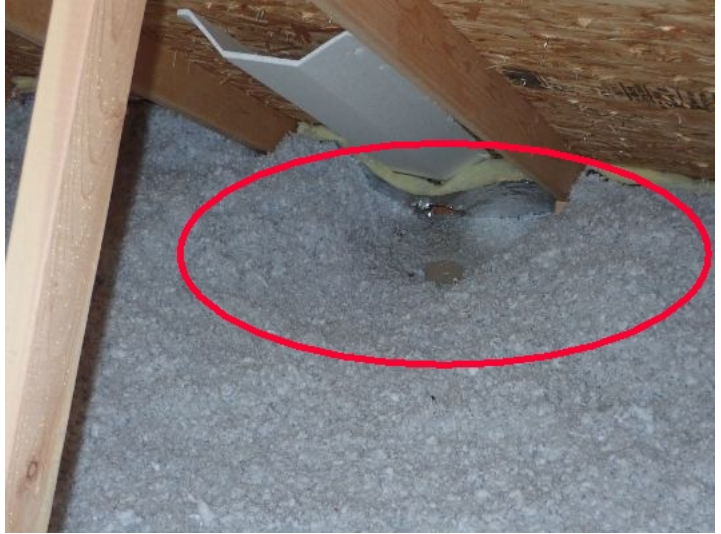
- Displaced insulation noted at the SE and SW corners of the garage attic. This displacement is caused when high winds enter the soffit venting. The soffit dams are not airtight in these locations and the insulation is blown out of place. We recommend improving the soffit dams and replacing the insulation to improve energy expenses.

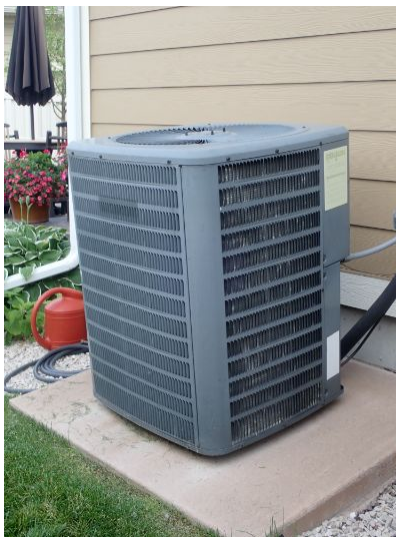
- Damaged fins observed at the **A/C** compressor. We recommend an HVAC contractor strighten the cooling fins to allow the unit to dissipate heat efficiently.
- Exterior unit not level. This can affect system performance and/or cause premature wear to the fan. Have the unit leveled for improved operation and lifespan.

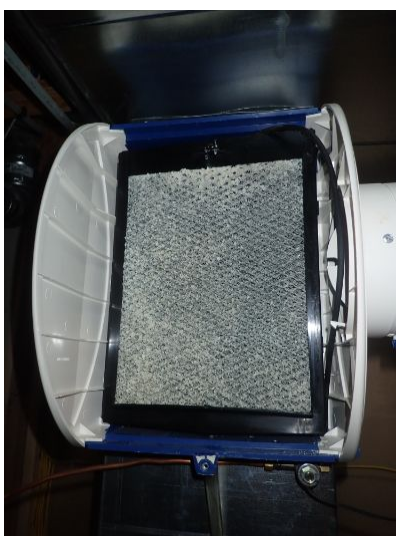
- Humidifier pad heavily built up with mineral deposits. Pad needs replaced.

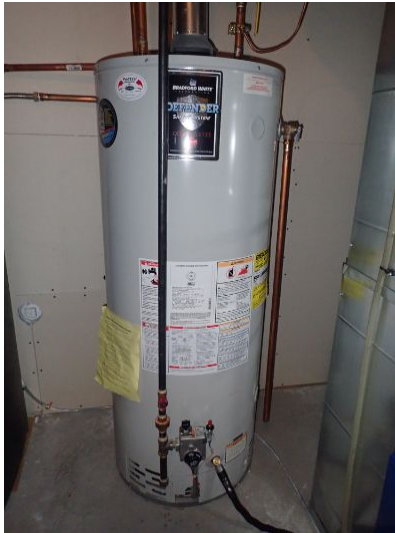
- Typical service life for a water heater is 10-15 years. Date of manufacture of this tank is 2007.
- Water temperature at the half bathroom was observed to be 108° F. We never recommend setting temperature greater than 120° F for scald concerns as well as to extend the life of the water heater.

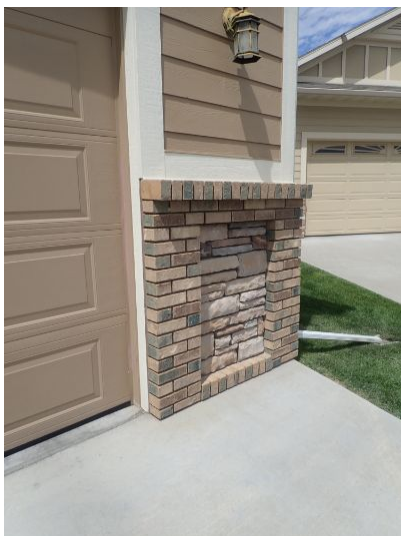
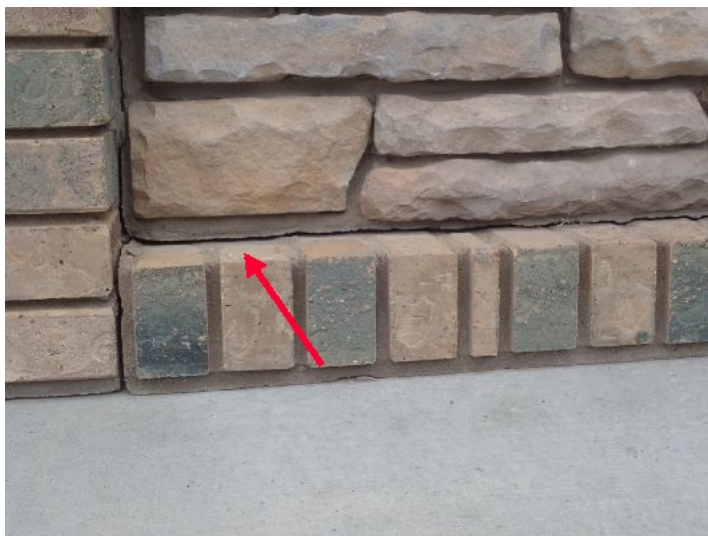
• The brick veneer at both the east and west sides of the overhead door is not secured/adhered to the garage wall. Cracking of the mortar joints also observed. We recommend a mason or qualified contractor repair as necessary.

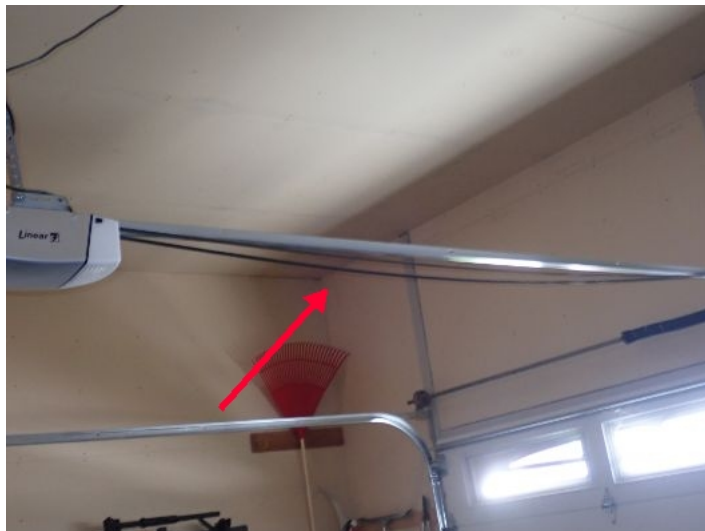
- The drive belt sags. Recommend tightening the belt to remove the slack and prevent wear.
- The garage door appeared functional during the inspection.

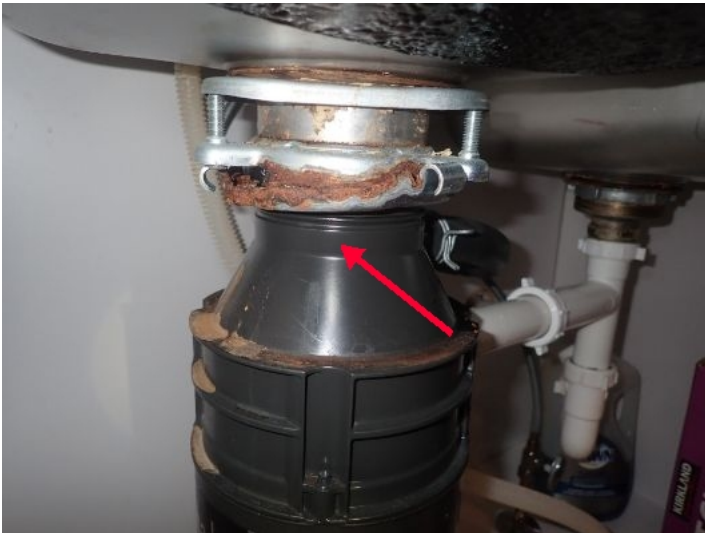
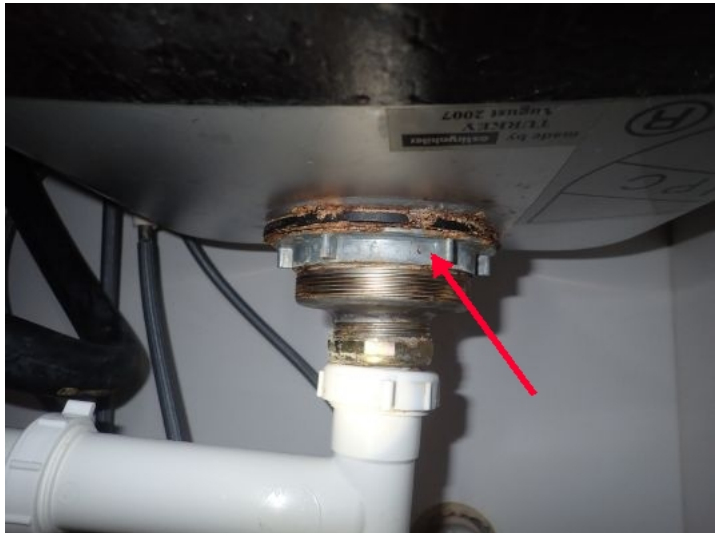
- The disposal is not properly attached to the sink basin. Evidence of leaks noted. There also appears to be leaks that have occurred at the right sink basin at the gasket. We recommend a licensed plumber review these connections and make any necessary repairs.
