# **20/20 Property Inspections, LLC**

## **Property Inspection Report**

1234 ABC Street, Billings, MT 59108  
Inspection prepared for: Happy Homebuyer  
Real Estate Agent: -

Date of Inspection: 2/21/2018 Time: 1:00pm  
Age of Home: 2005 Size: 3,456 sf  
Weather: 55°F Sunny

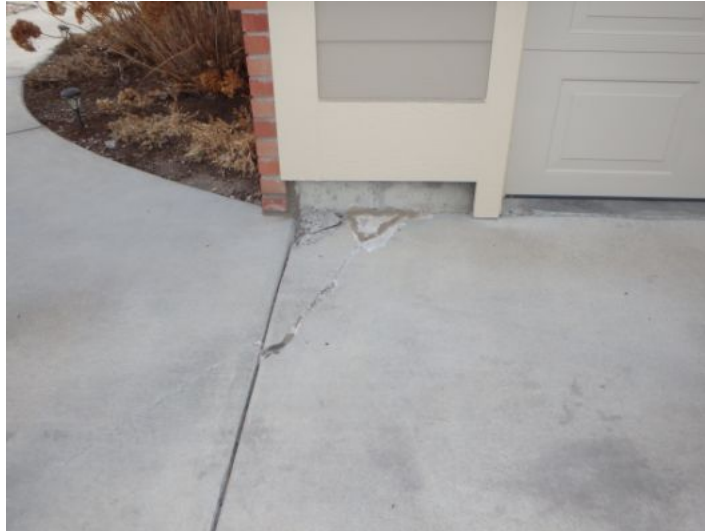
- Some cracking of the driveway observed near the NE corner of the garage. The driveway slab appears to have settled in this area. Recommend patching the damaged portions.

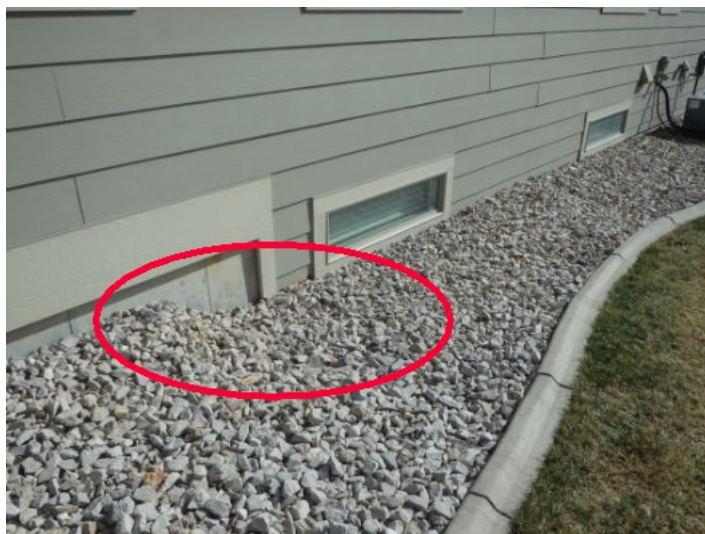
- Landscape materials observed to be in contact with siding at the west side of the home. It would be wise to install small retaining walls at this side of the home. This will allow an opportunity to create a drainage pattern that would keep runoff away from the foundation as well as create proper clearances between siding and landscape.

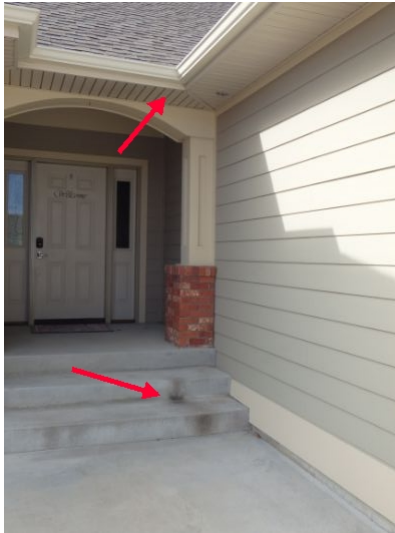
- Evidence of leaks noted at the gutter system above the front entryway. The gutters appear to have been replaced since the past hailstorms and this leak appears to be a non issue. Monitor during storms.

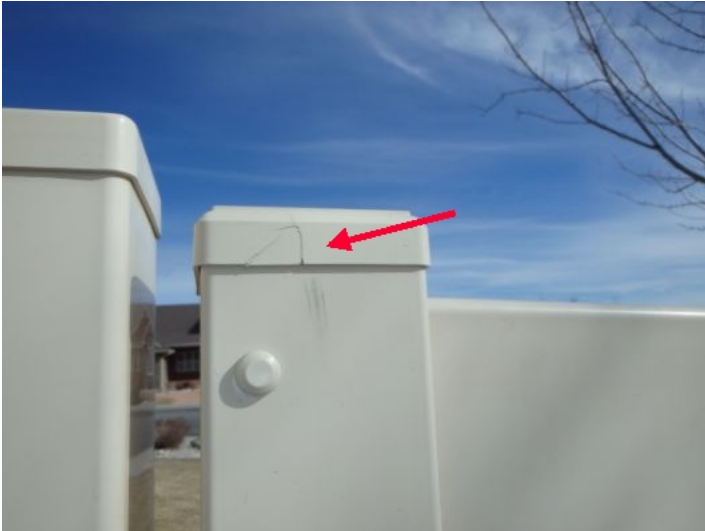
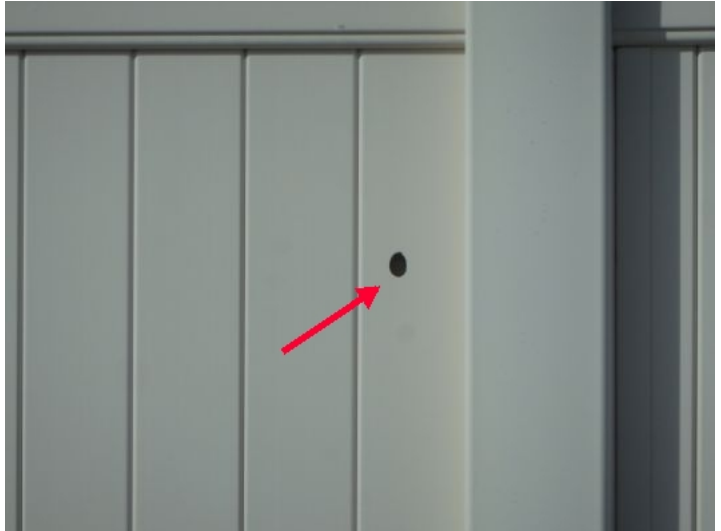
- A hole was observed in a panel at the west end of the south fence system. This may be hailstone damage.
- Cracked cap noted at the post adjacent to the gate. Recommend replacing this cap.

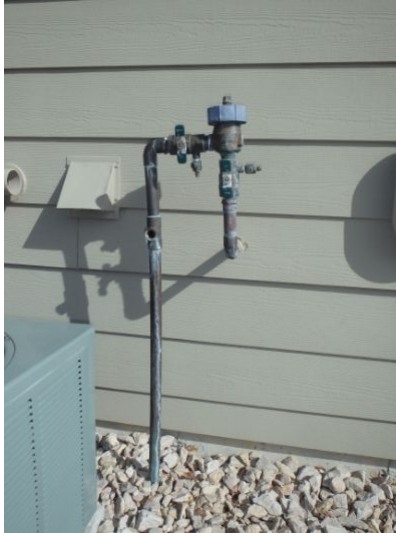
- Home is equipped with an underground sprinkler system. The system was not operated due to winterization. The inspector recommends client refer to the Seller's Disclosure Statement regarding the operational status of the system and request previous invoice for proof of winterization. Sprinkler systems are beyond the scope of a Home Inspection, due to most of its parts/piping not visible for inspection.

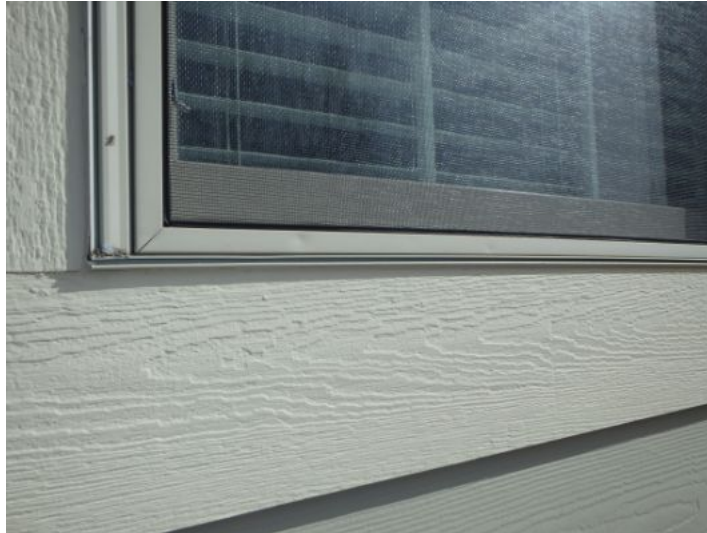
- Hailstone dings were observed at the west facing windows. The aluminum cladding is cosmetically damaged. Recommend review of the insurance claim reporting to determine if these are to be repaired/replaced.

Exterior Areas		
Page 7 Item: 2	Window Condition	• Hailstone dings were observed at the west facing windows. The aluminum cladding is cosmetically damaged. Recommend review of the insurance claim reporting to determine if these are to be repaired/replaced.
Basement/Crawlspace		
Page 15 Item: 1	Walls	• Some cracking of the drywall apparent at the center load bearing wall and adjoining ceiling. The basement floors were noted to be uneven. There may have been some heaving of the slab or settlement that has occurred. A structural specialist would need to review if concerned.
Page 15 Item: 6	Windows	• The window wells at the south side of the home have heaved inward. There also was evidence of erosion at the sides of the wells as soils were present within. There is a downspout at the southwest corner of the home that is sending runoff toward this area and due to level to negative drainage, collecting near the wells. It is advised to improve grading at the southwest corner of the home (consider addition of a short retaining wall).

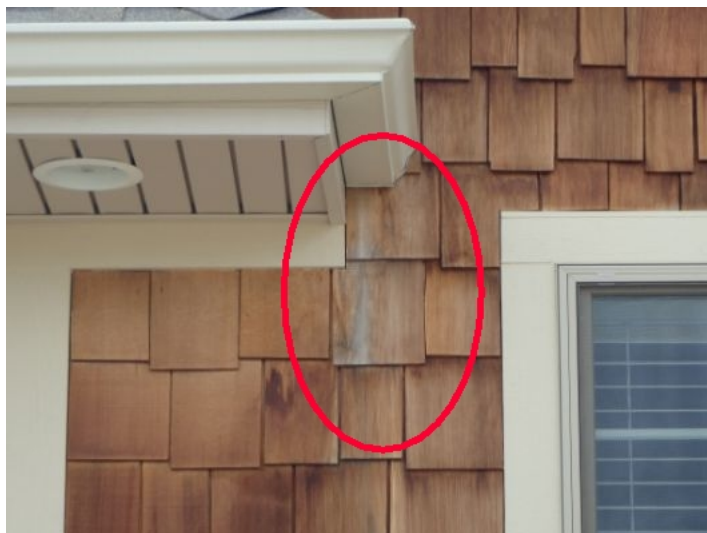
- Staining of the shakes present at the front of the home due to past gutter leaks. The gutter systems have been replaced and this likely has been addressed.

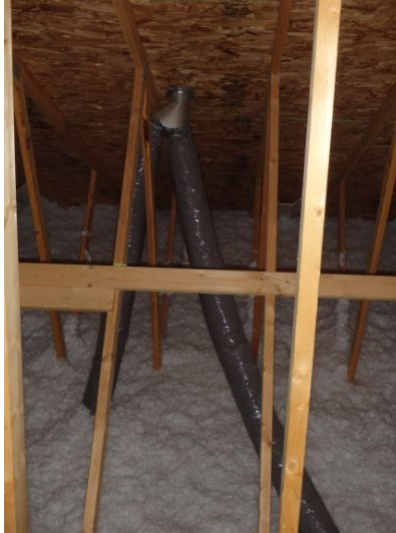
- Vents through roof
- The exhaust ducts for both bathrooms share a through the roof vent. This is no longer recommended practice as if the fans are running simultaneously they compete for air space or humid exhaust air can be directed from one room to another. This also can cause condensation to build up at the Tee fitting and potentially leak into the attic. It is advised to install an additional through the roof vent kit to allow the fans to be independently ducted to the exterior.

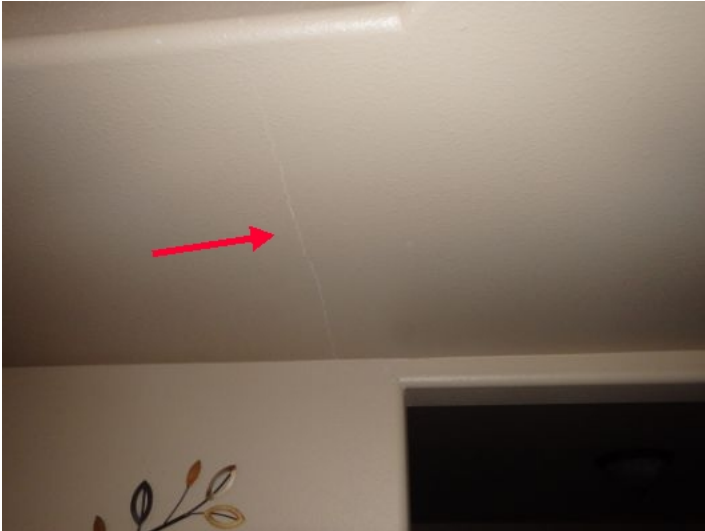
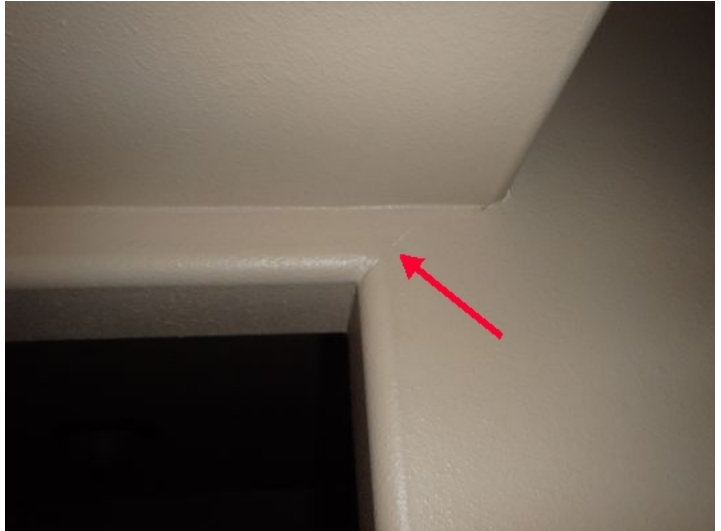
• Some cracking of the drywall apparent at the center load bearing wall and adjoining ceiling. The basement floors were noted to be uneven. There may have been some heaving of the slab or settlement that has occurred. A structural specialist would need to review if concerned.

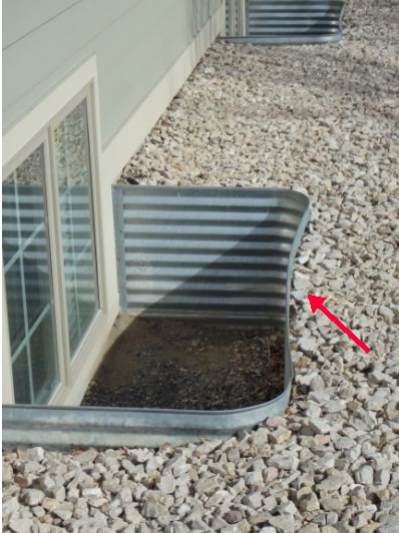
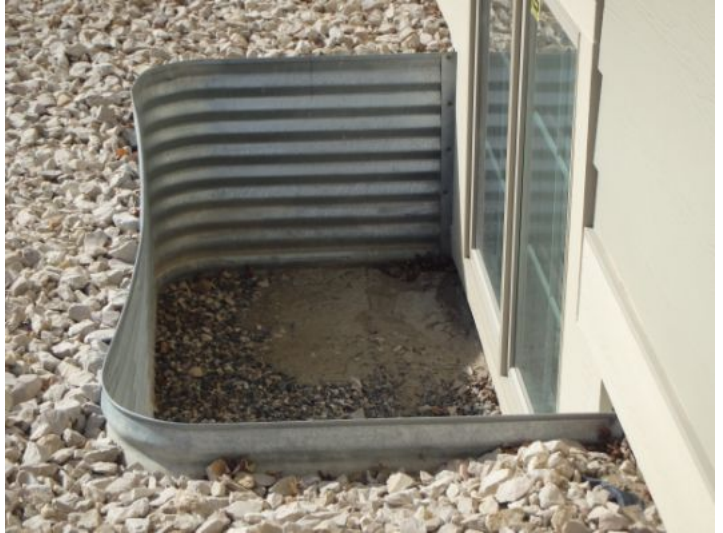
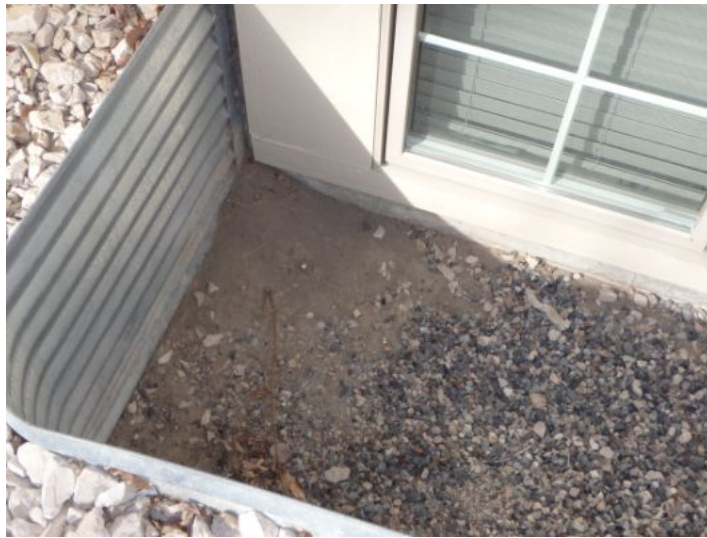
• The window wells at the south side of the home have heaved inward. There also was evidence of erosion at the sides of the wells as soils were present within. There is a downspout at the southwest corner of the home that is sending runoff toward this area and due to level to negative drainage, collecting near the wells. It is advised to improve grading at the southwest corner of the home (consider addition of a short retaining wall).

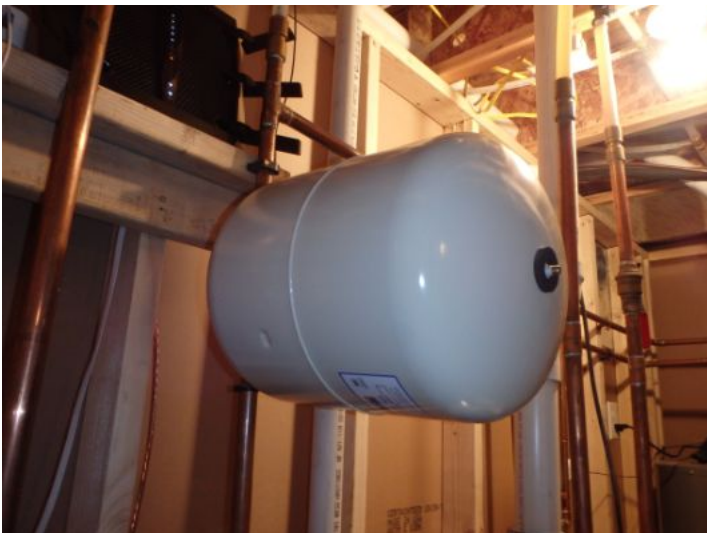
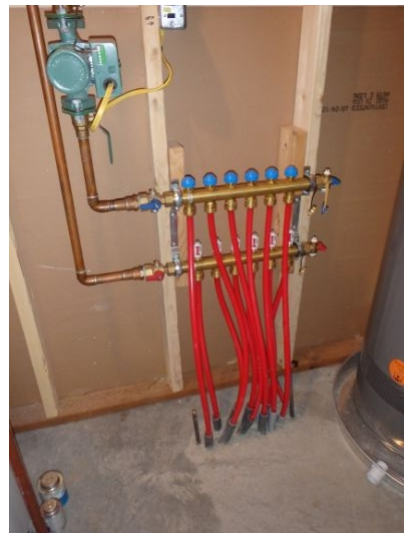
- **Expansion tank** had no air in the bladder. Recommend a plumber recharge this tank.

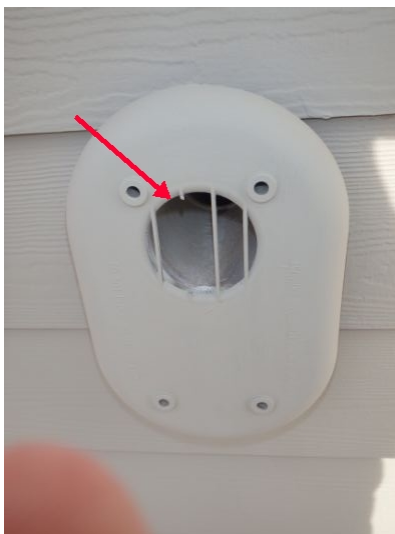
Damaged exterior vent cover at the west side of the home, possible hailstone damage.

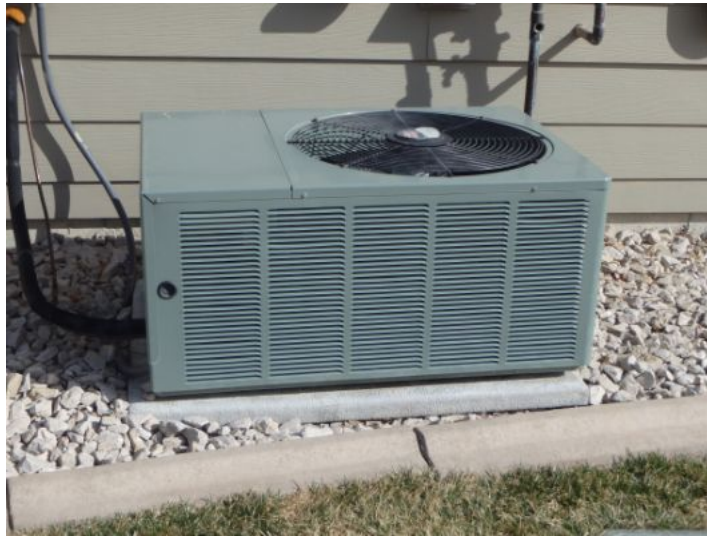
- The **A/C** condenser was not operated due to exterior temperatures below 65F. Operating a compressor in cold weather can severely damage the unit. We recommend referring to the seller's disclosure statement regarding the operational status of the A/C system. We also recommend operation of the unit during the final walk-through, weather permitting.

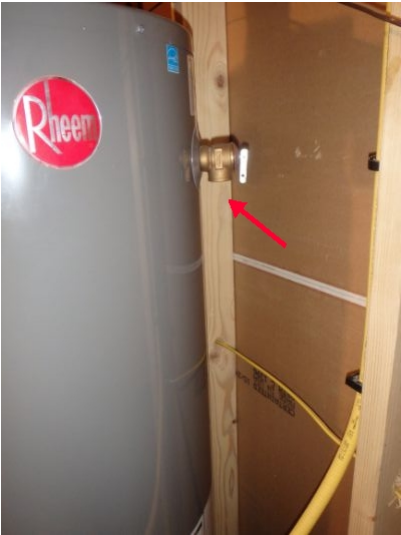
- The extension at the water heater relief valve is missing. This is a potential scalding concern as water can discharge improperly. Recommend installing the proper type of relief extension to discharge within 6 to 8" from the floor.

Water Heater		
Page 24 Item: 7	Overflow Condition	• The extension at the water heater relief valve is missing. This is a potential scalding concern as water can discharge improperly. Recommend installing the proper type of relief extension to discharge within 6 to 8" from the floor.

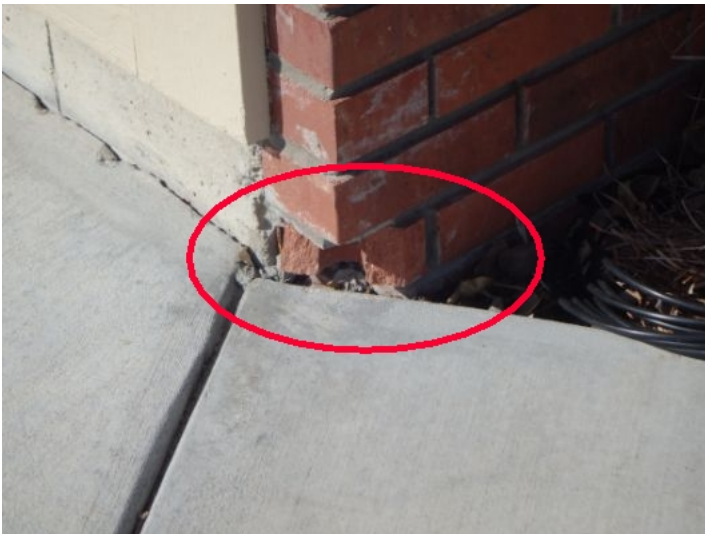
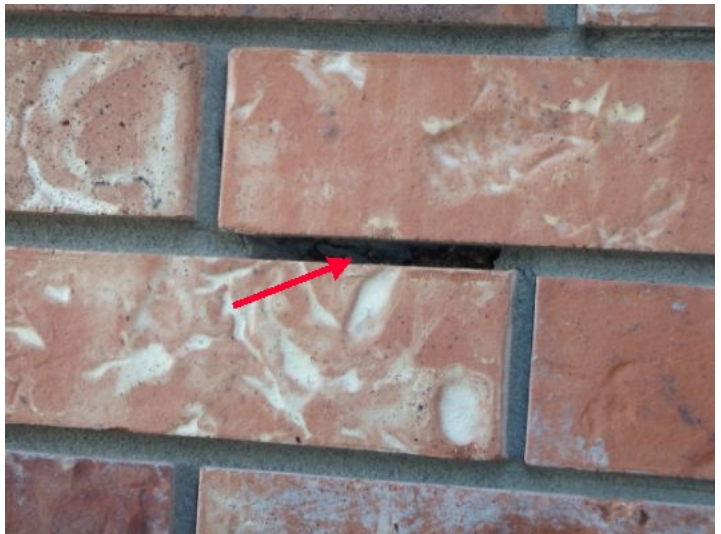
- Cracking of the brick veneer was observed at both sides of the east wall. The walkway and driveway appears to have shifting causing uplift cracking the bricks. There also was areas of missing mortar at some of the joints. We recommend a mason review and make repairs.

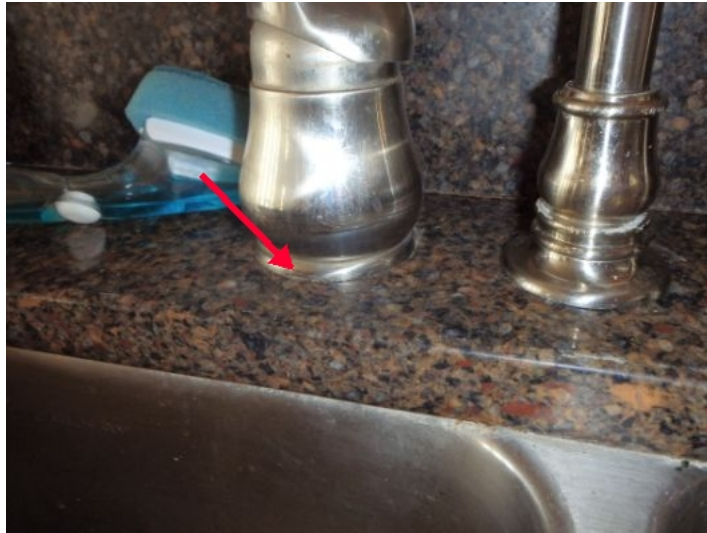
Minor leak present at the kitchen faucet. Recommend a plumber replace the valve seals.

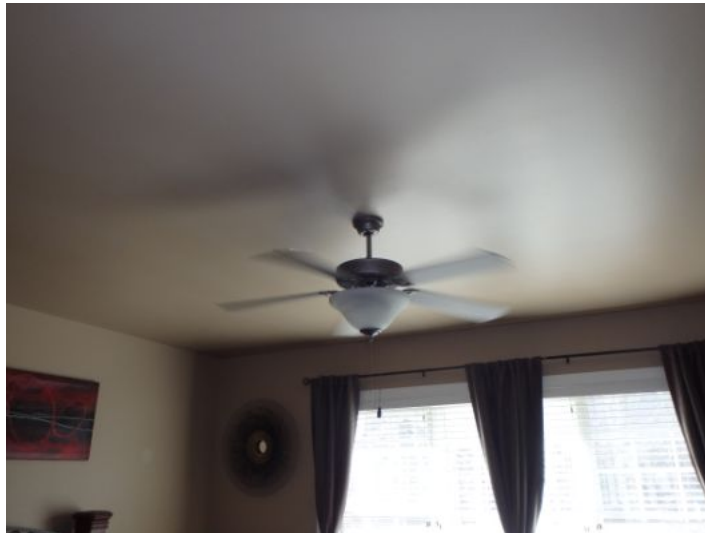
Ceiling fan in the master bedroom wobbles. May need a balance kit installed.

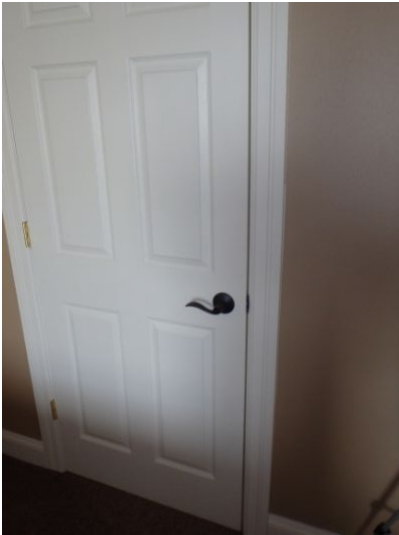
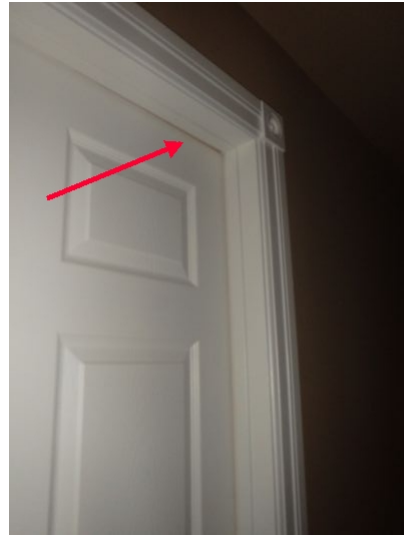
- Several doors in the basement do not latch and/or are not closing square within their frames. Recommend a finish contractor review this condition and make corrections.
